Aerial photographs of the southwest side of Cedar Lake taken in 2005 and 2006

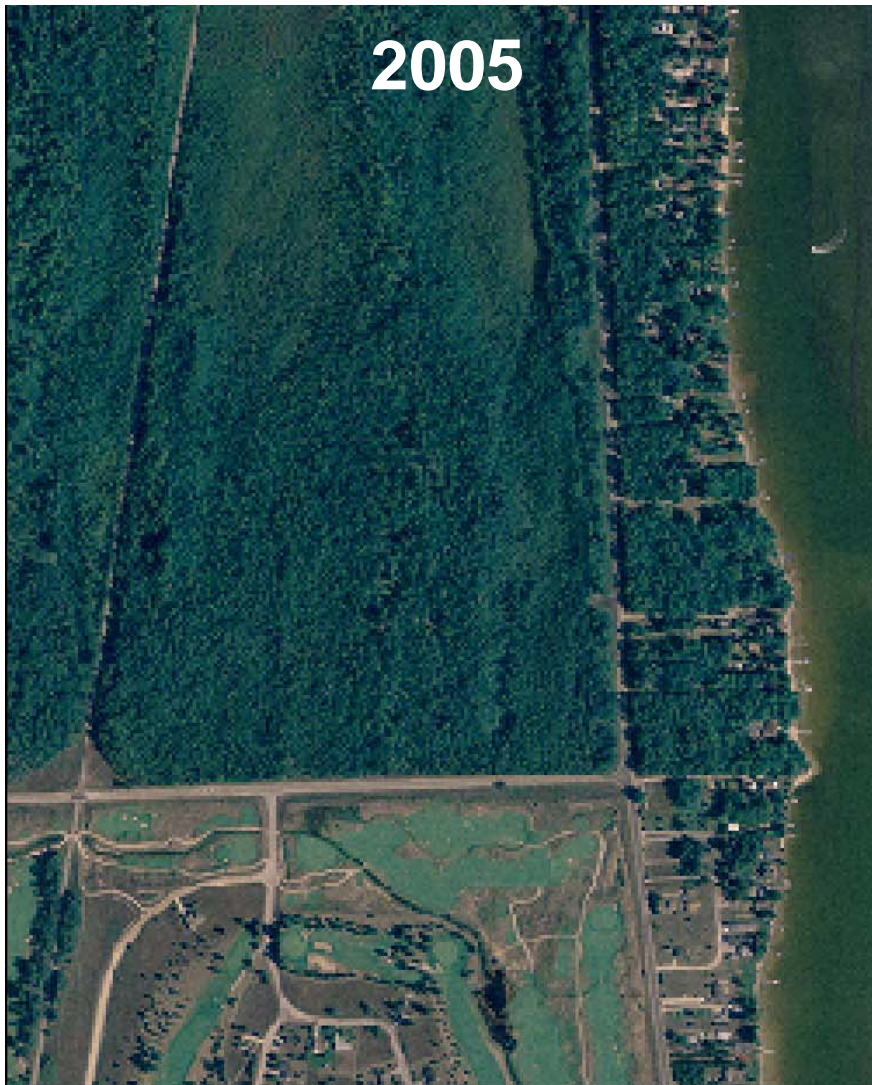
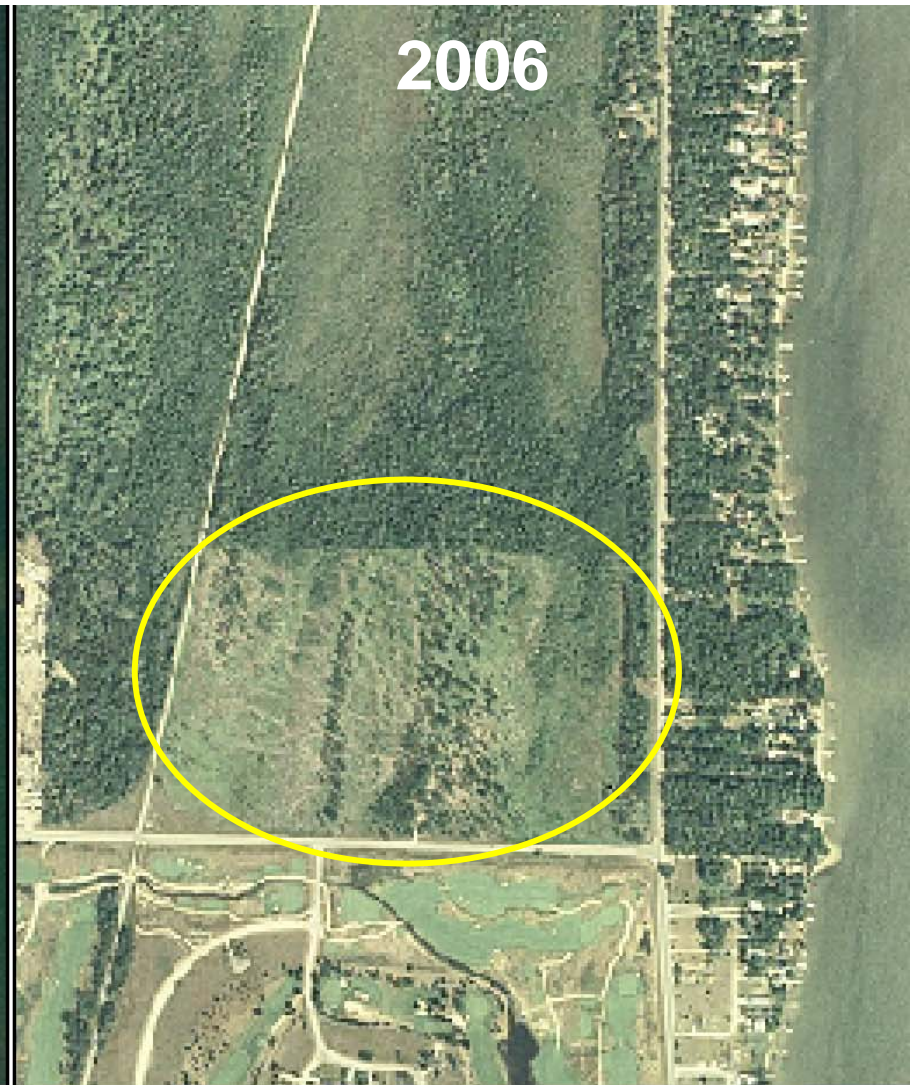
On the 2006 photograph on the right, the outlined area shows the extent of clear cutting that occurred at the wetland along the north side of Kings Corner Road. The land cover change (from forested to open field) is an example of how development activities can impact the hydrology of this area, and ultimately Cedar Lake.
