CMI Project Report  
Kalamazoo River Watershed Critical Erosion Sites Mitigation Project

Site #1 –Final Report  
Section 7 of Convis Township, Calhoun County

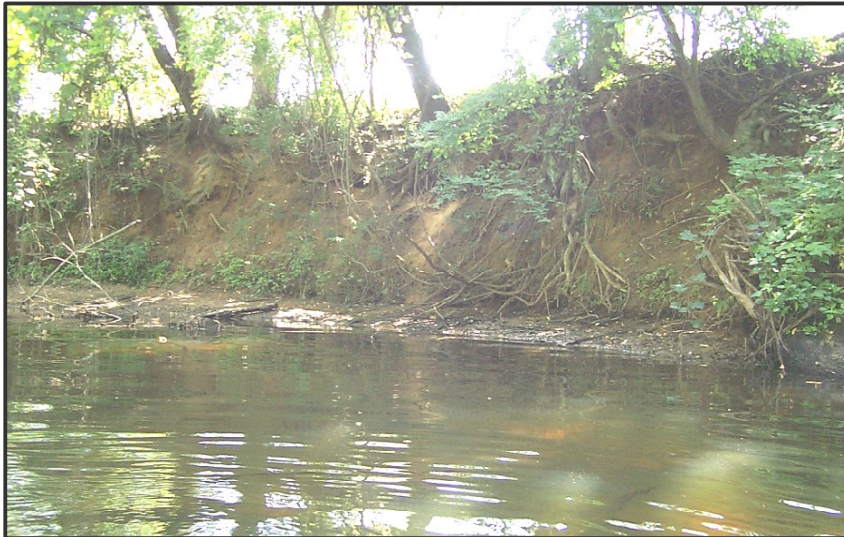
This site was a high outside bank of a sharp bend in the Battle Creek River and is susceptible to high energy drag forces at stream forming flow levels that is continually undercutting the bank. The land directly adjacent to the riverbank is actively used, productive, tillable cropland. The landowner is a full time farmer that desires to stabilize and restore the bank to keep from losing any more of the bank that would cause the loss of trees and the buffer strip along the edge of his crop fields. Left unchecked, the bank would continue to erode, causing the loss of land including the loss of valuable cropland. Site is about 300 ft long and 20 ft high.

“Before” pic showing undercutting and erosion:

With the assistance of DEQ engineers it was determined that a solution employing a “live crib wall” would provide the hard revetment needed to stabilize the base of the bank and provide a bioengineering solution to stabilize the entire embankment.

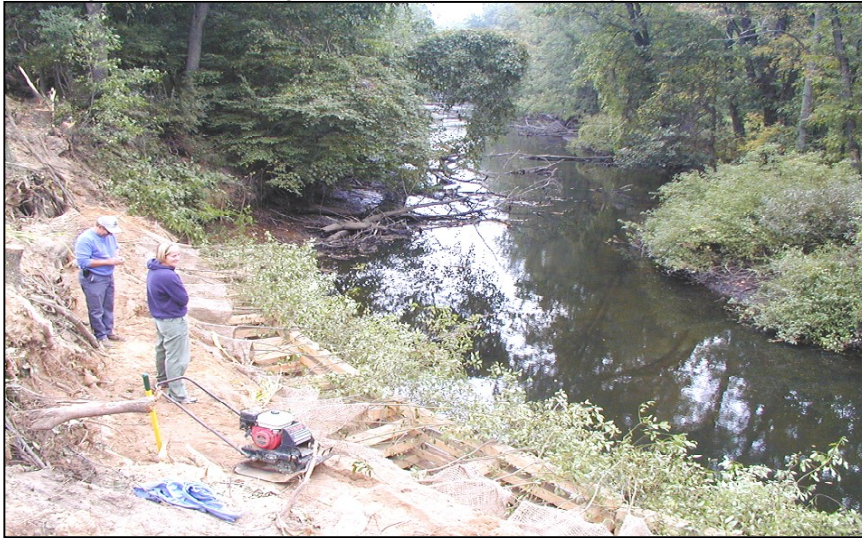
"During" pic illustrating crib walls and live cutting placement:

Calhoun Conservation District applied for permit in May of 2003 to rebuild the eroded riverbank and stabilize the bank with bioengineering and rock crib walls consisting of rock and wood posts. An operation and maintenance agreement with landowner was signed in May of 2003. Contractor was chosen during July, 2003 through a bid process. Permit was granted on August 18, 2003 and work began immediately. Work was completed during September, 2003. Low water levels were beneficial to this project, making entire project quicker and easier. No significant problems or delays were encountered.

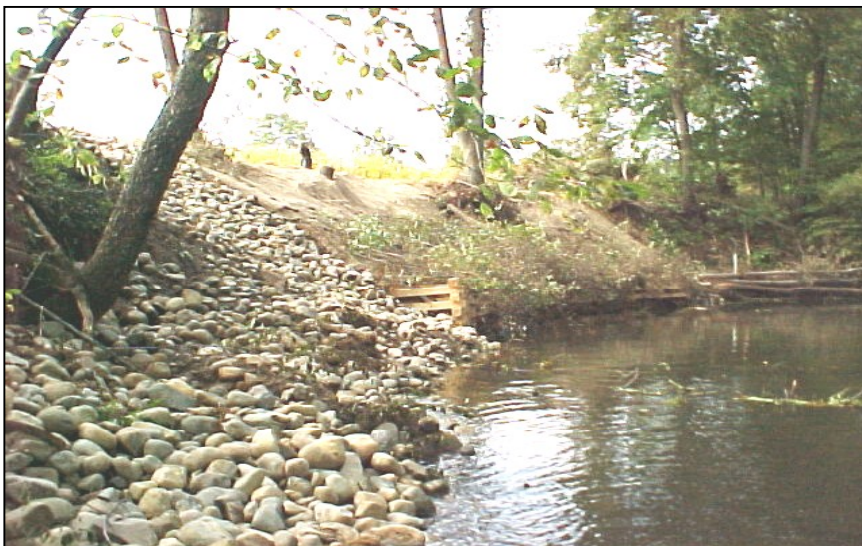
"After" pic showing rock rip rap, crib walls, and vegetation:
