"AB" AVENUE - AUGUSTA CREEK
SUMMARY OF WATER CROSSING IMPROVEMENT PROGRAM
Kalamazoo County Road Commission
February 2004

SITE NAME "AB" Avenue at Augusta Creek
SITE LOCATION Ross TWP, NW1/4, SE1/4, Sec 3, 0.1 mi west of 44th St. on "AB" Ave.
WATERSHED NAME Kalamazoo
SUB-WATERSHED NAME & SIZE Augusta Creek, approx. 17 sq mi.
WATER BODY NAME Augusta Creek
SITE DESCRIPTION: Two lane aggregate road at 1-6% grade crossing Augusta Creek by concrete bridge. Road was aggregate and contained excessive road bank slopes with eroding shoulders that resulted in sediment laden and heated storm water runoff directly entering Augusta Creek.

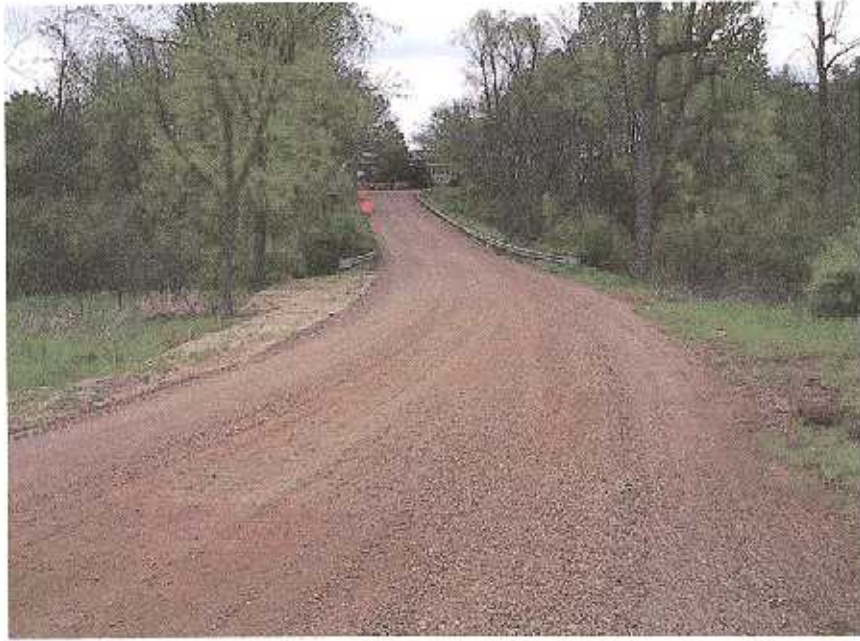
AB AVENUE LOOKING EAST PRIOR TO BMP CONSTRUCTION, JULY 2003

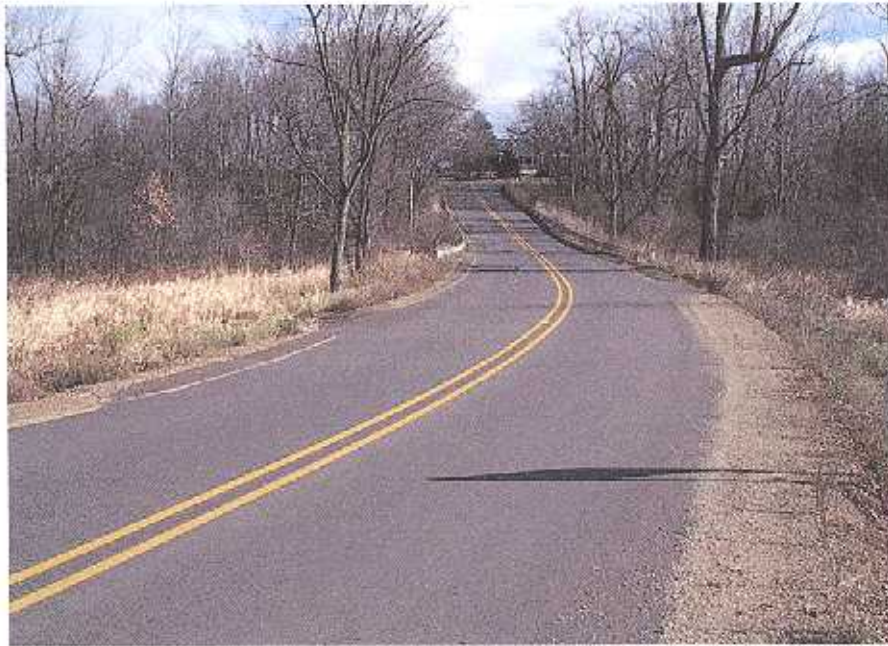
AB AVENUE LOOKING EAST AT FOLLOWING BMP CONSTRUCTION,
NOVEMBER 2003

- 1 Asphalt paved 705 feet of "AB" Ave. westward from 44th St.
- 2 Constructed asphalt curbs to direct runoff through BMP chain.
- 3 Stabilized sub shoulders with appropriately sloped & graded gravel.
- 4 Constructed two low-sloping asphalt storm water spillways.
- 5 Stabilized toe of spillways with graded rip rap, geotextile and enhanced lowland vegetation.
- 6 Silt fencing and other sediment entrapment devices were installed during construction activities.

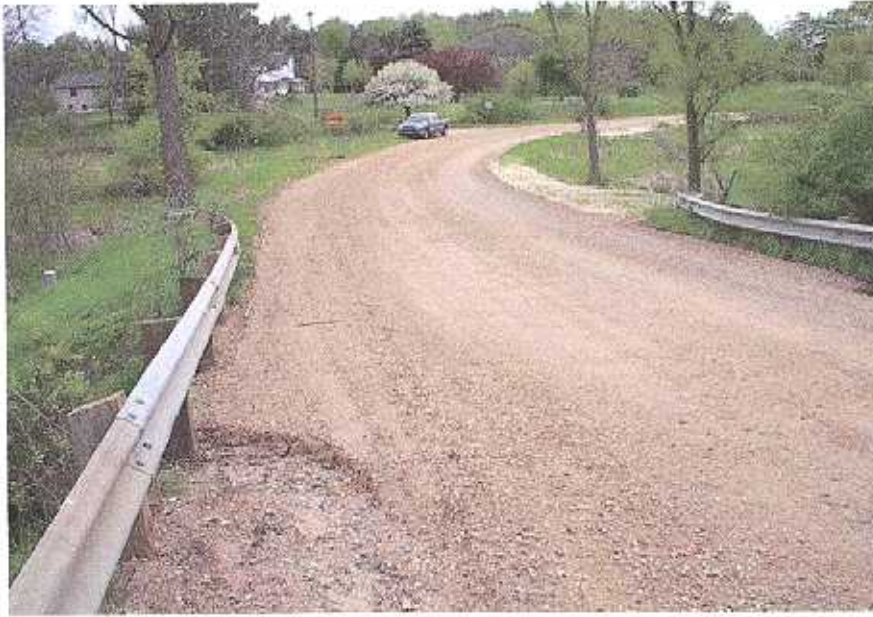
AB AVENUE LOOKING WEST AT SOUTH CROSSING PRIOR TO BMP
CONSTRUCTION, JULY 2003

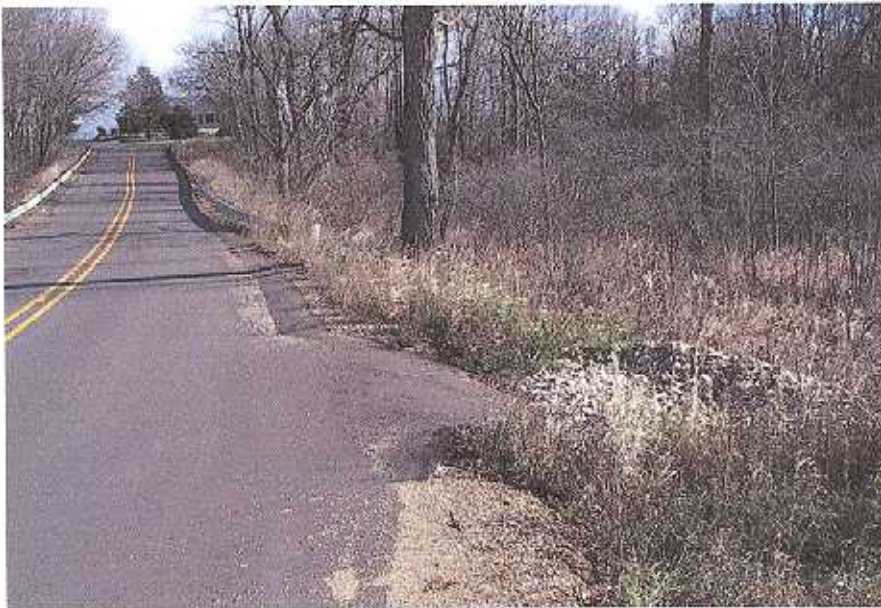
AB AVENUE LOOKING EAST AT SOUTH SPILLWAY, FOLLOWING
CONSTRUCTION, NOVEMBER 2003
